# USGS Bathymetric Survey Capabilities for Quantitative and Qualitative Assessments

## How does the USGS collect bathymetry data?

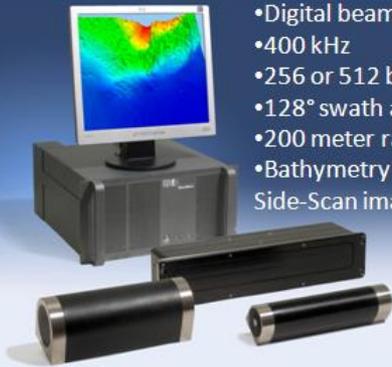
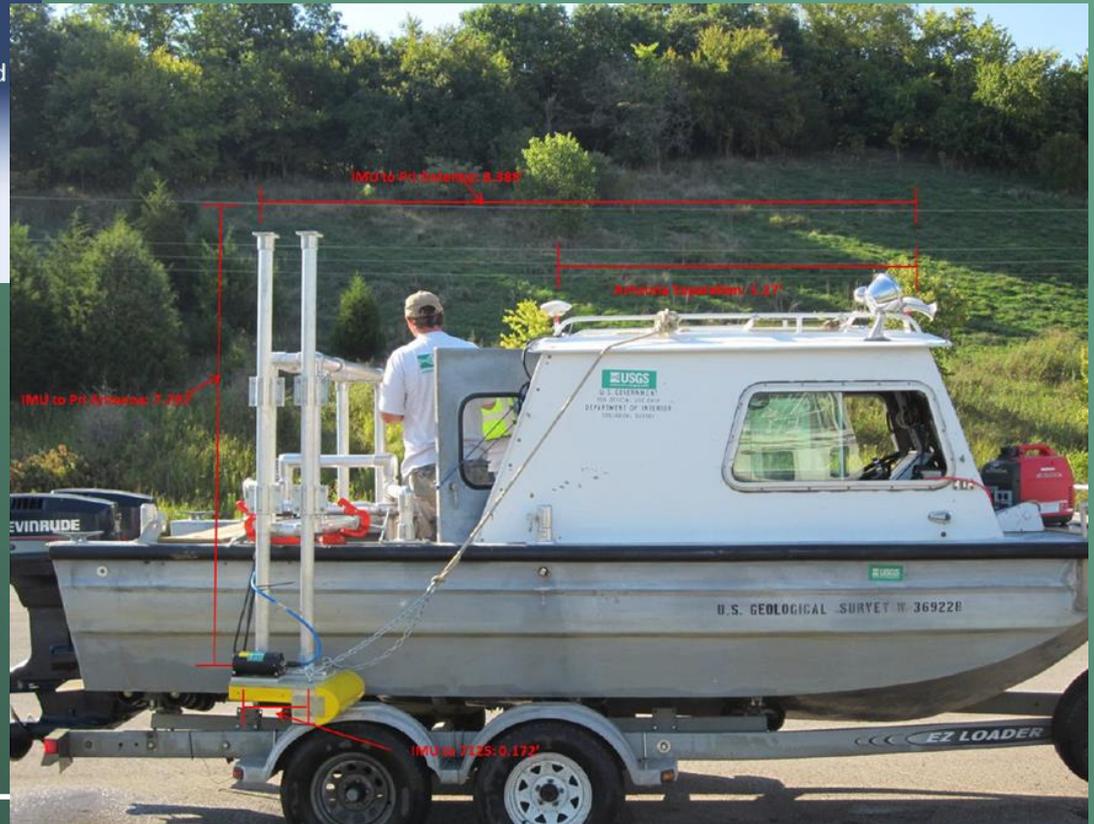
## RESON Seabat 7125 Multibeam Echosounder System

- Digital beam-former
- 400 kHz
- 256 or 512 beams
- 128° swath angle
- 200 meter range
- Bathymetry data and Side-Scan imagery

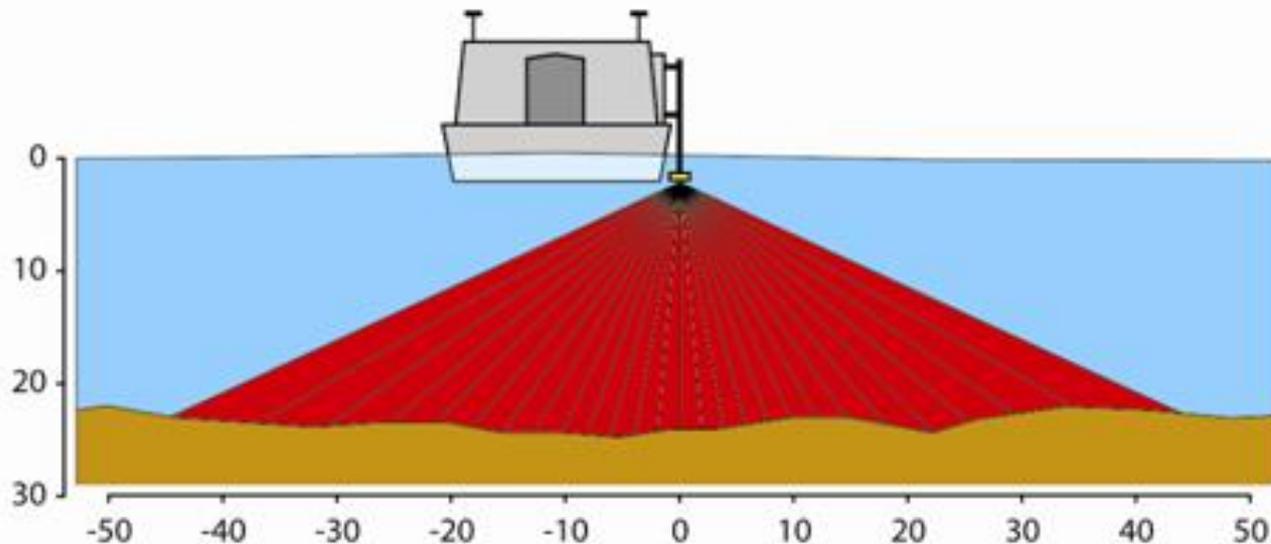
- Wide yet narrow swath perpendicular to the boat direction
- Multiple beams in just one ping
- ***SURVEYS the ENTIRE RIVER or LAKE BED***

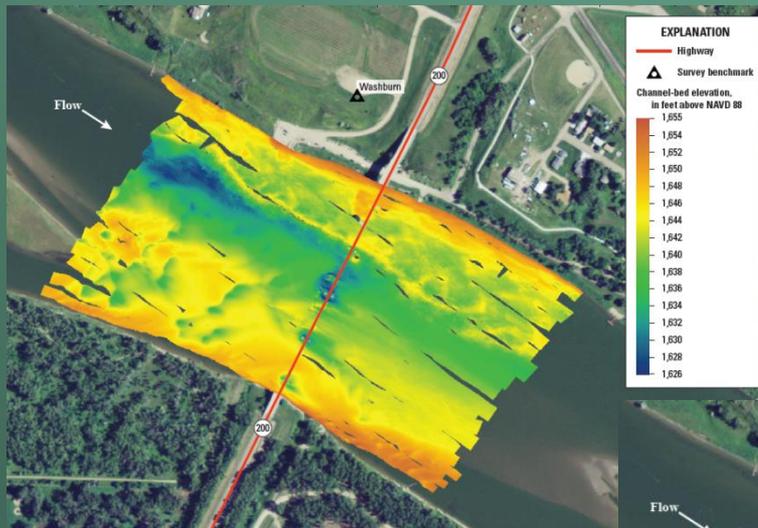
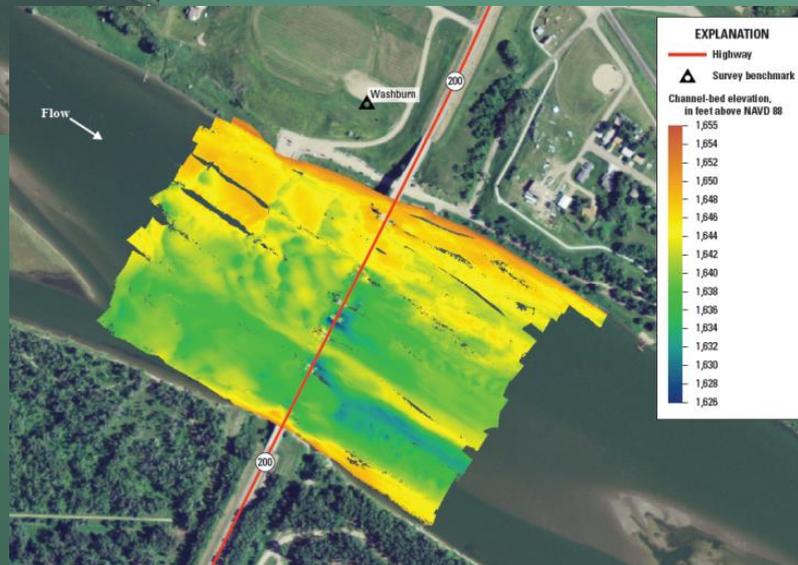
Map results on June 9, 2011  
← before an event

Map results on July 9, 2011  
after an event →

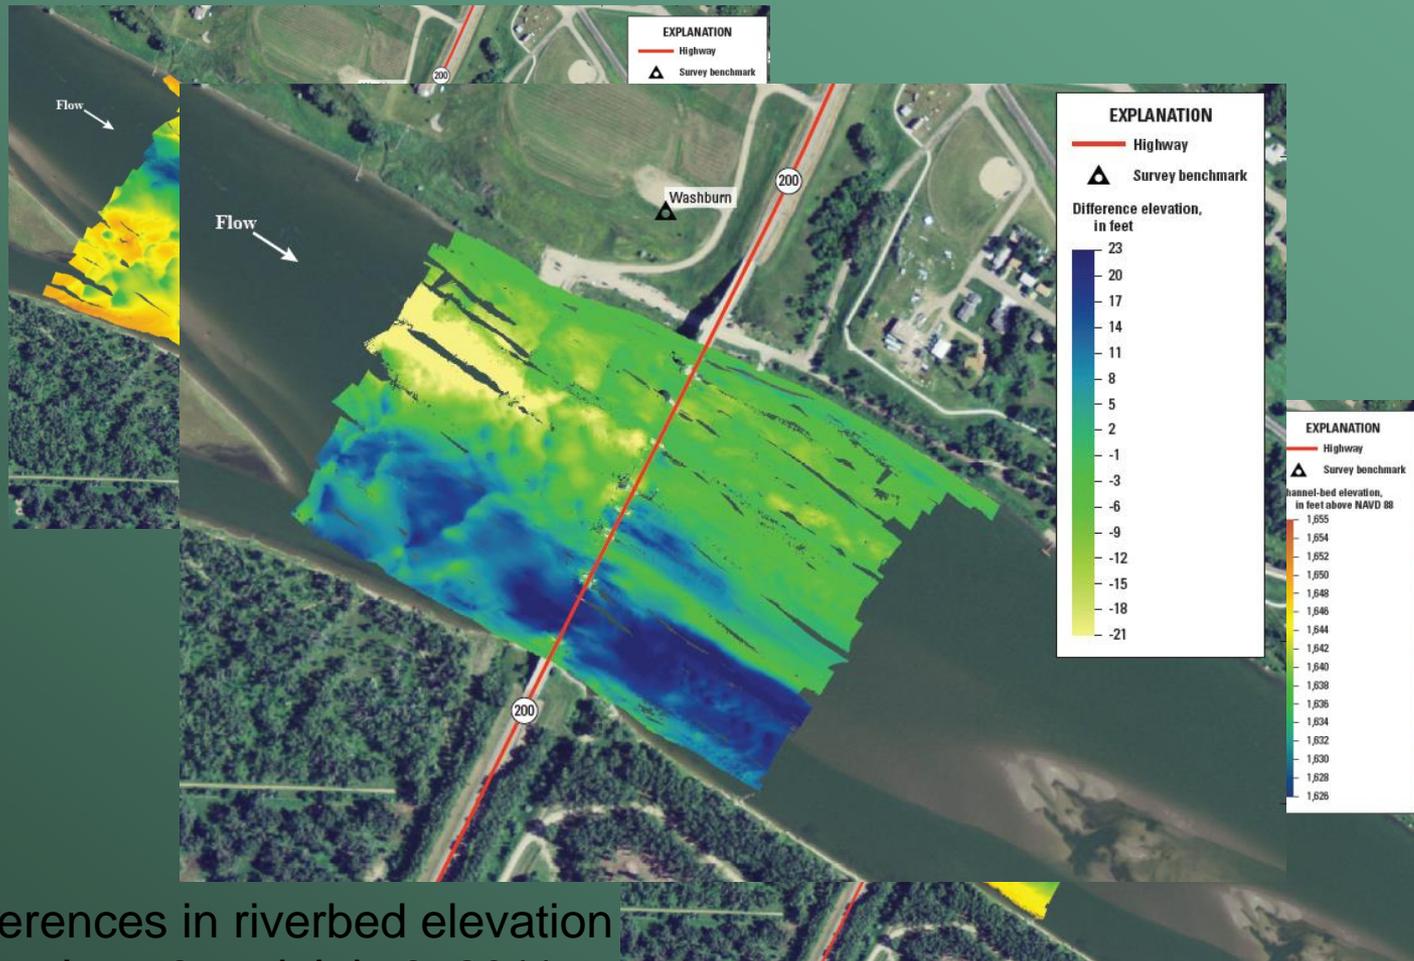
Differences in riverbed elevation  
on June 9 and July 9, 2011

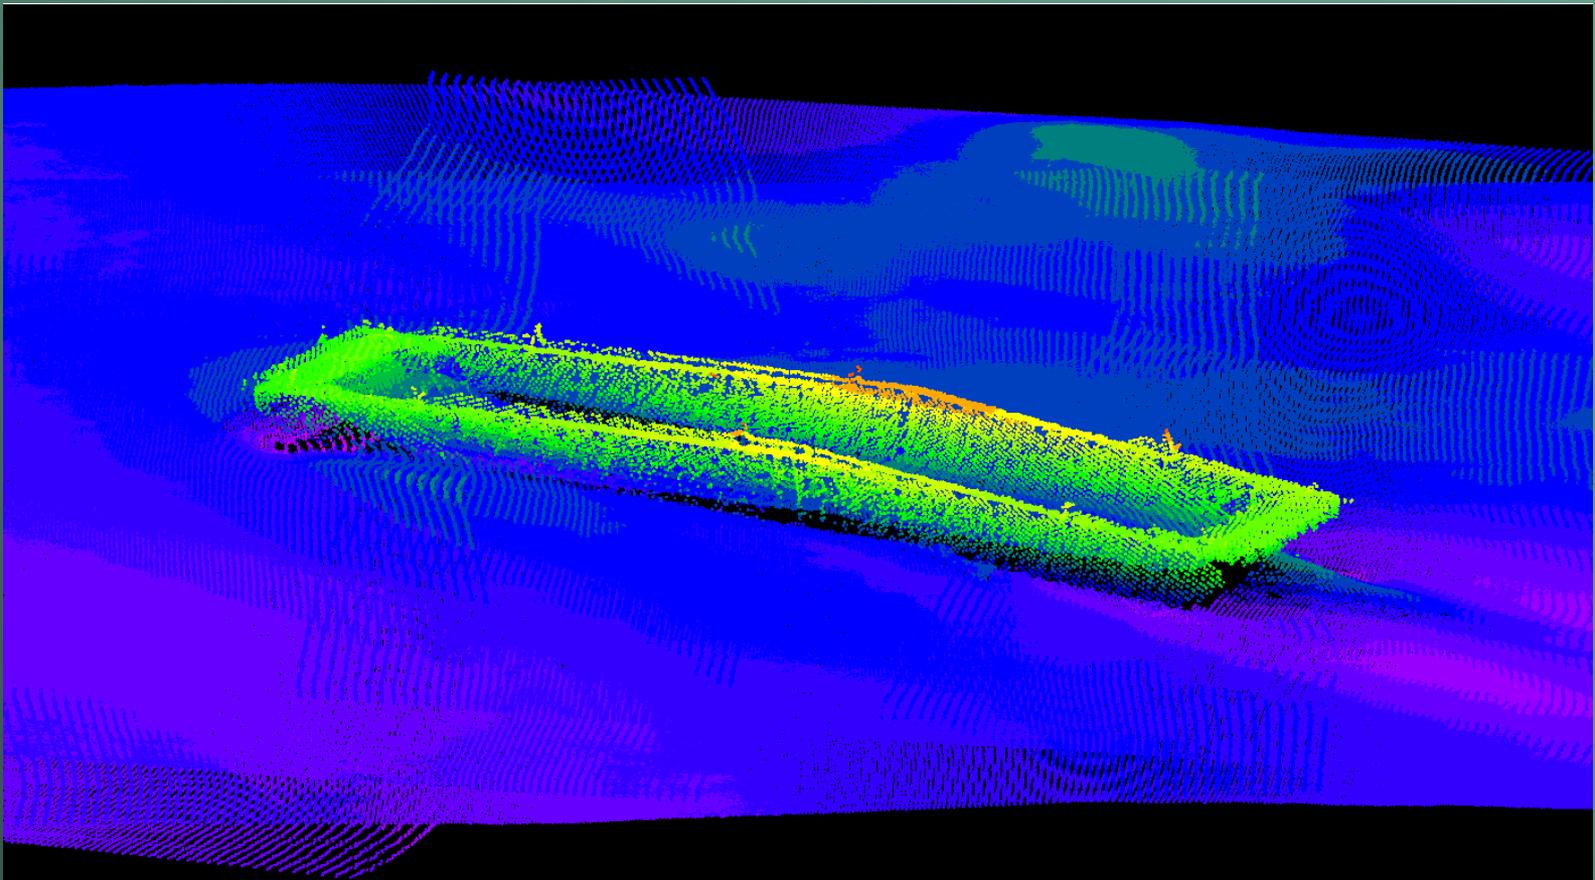
Sunken Barge in the Ohio River near Louisville Water intakes found 8/24/2012

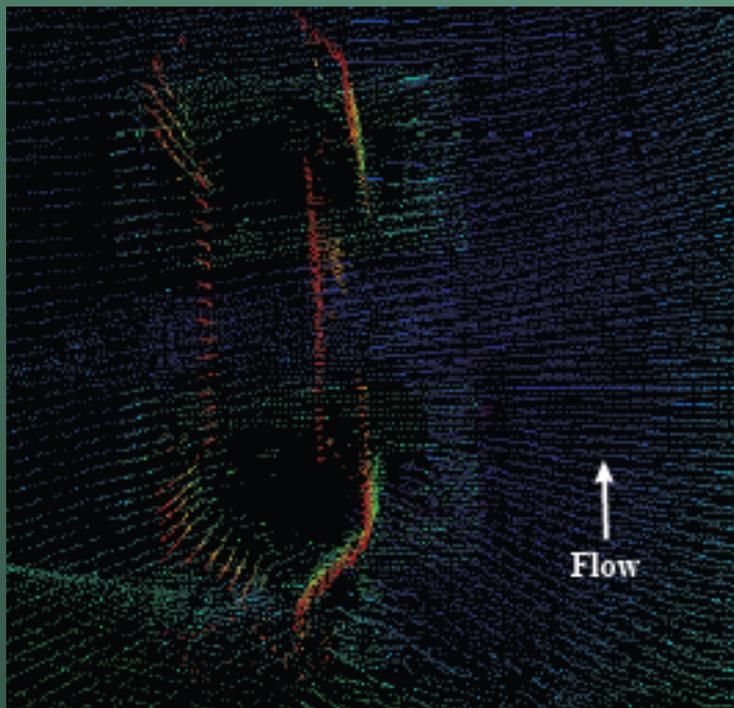
TIN- rendered surface

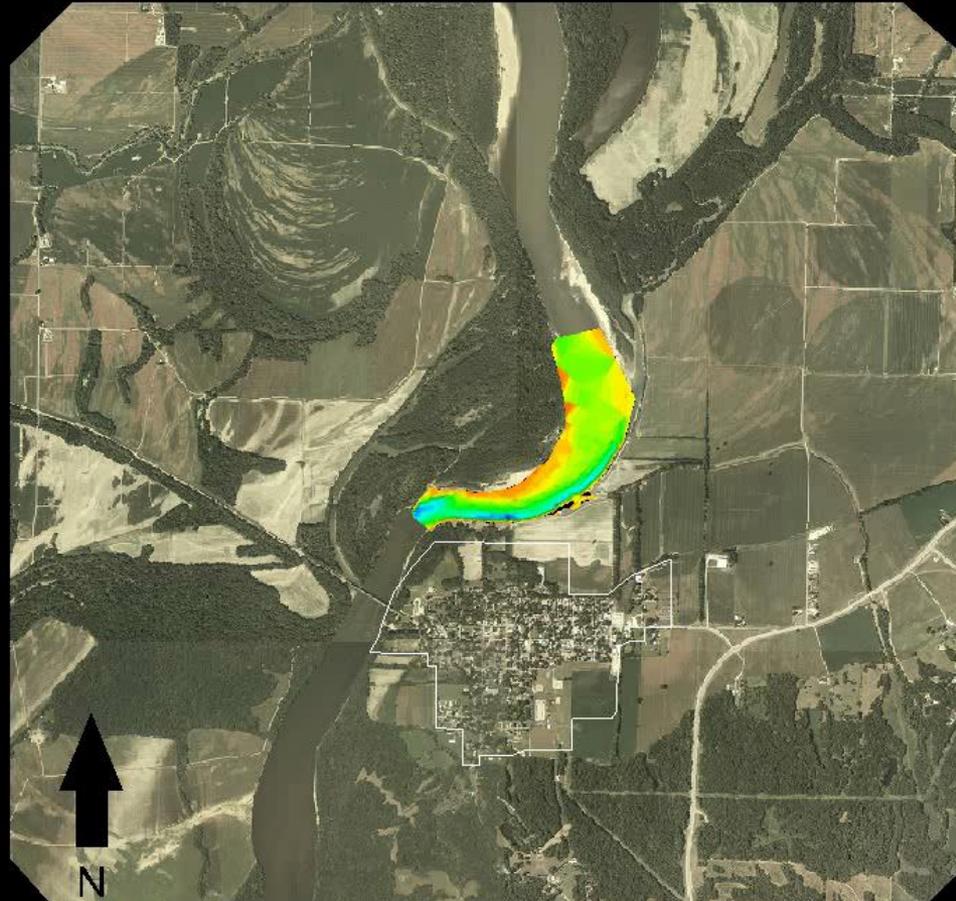
**Bathymetric and Velocity survey of the Wabash River  
near New Harmony, Indiana**

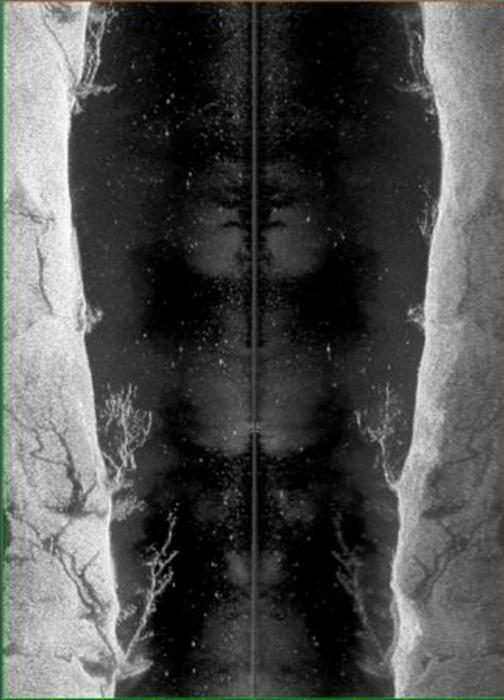
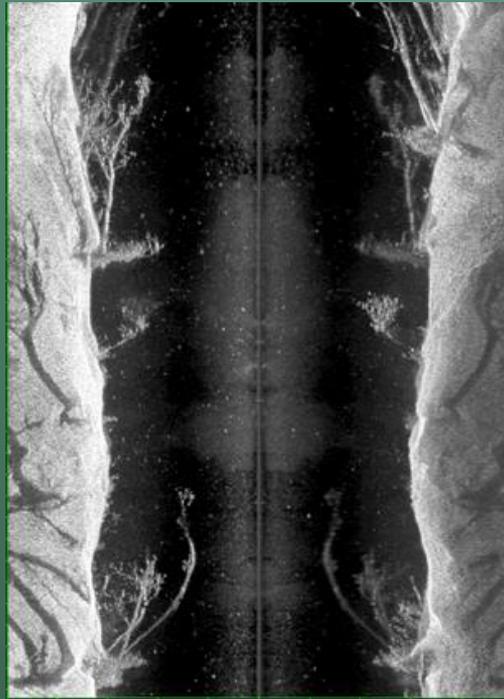
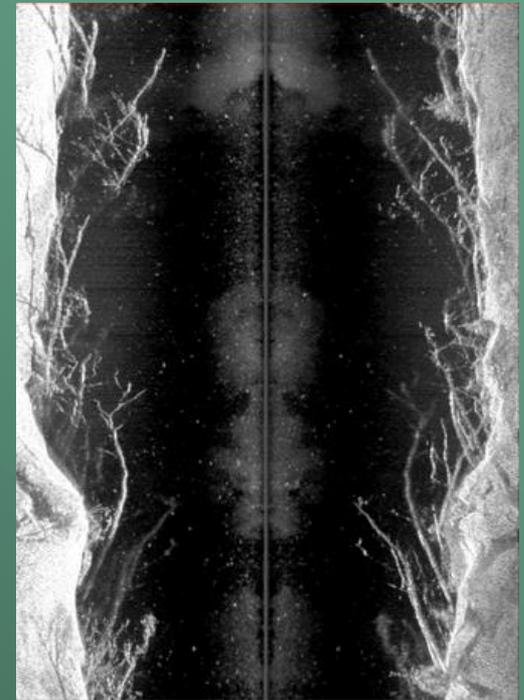
Submerged trees at Wabash River
